# Milestone Inspection Report Phase 1

## Beaumer Condominium Association, Inc.

**805 Riverpoint Drive, Building A 801  
Naples, FL 34102**

Prepared on:  
**5/24/2024**

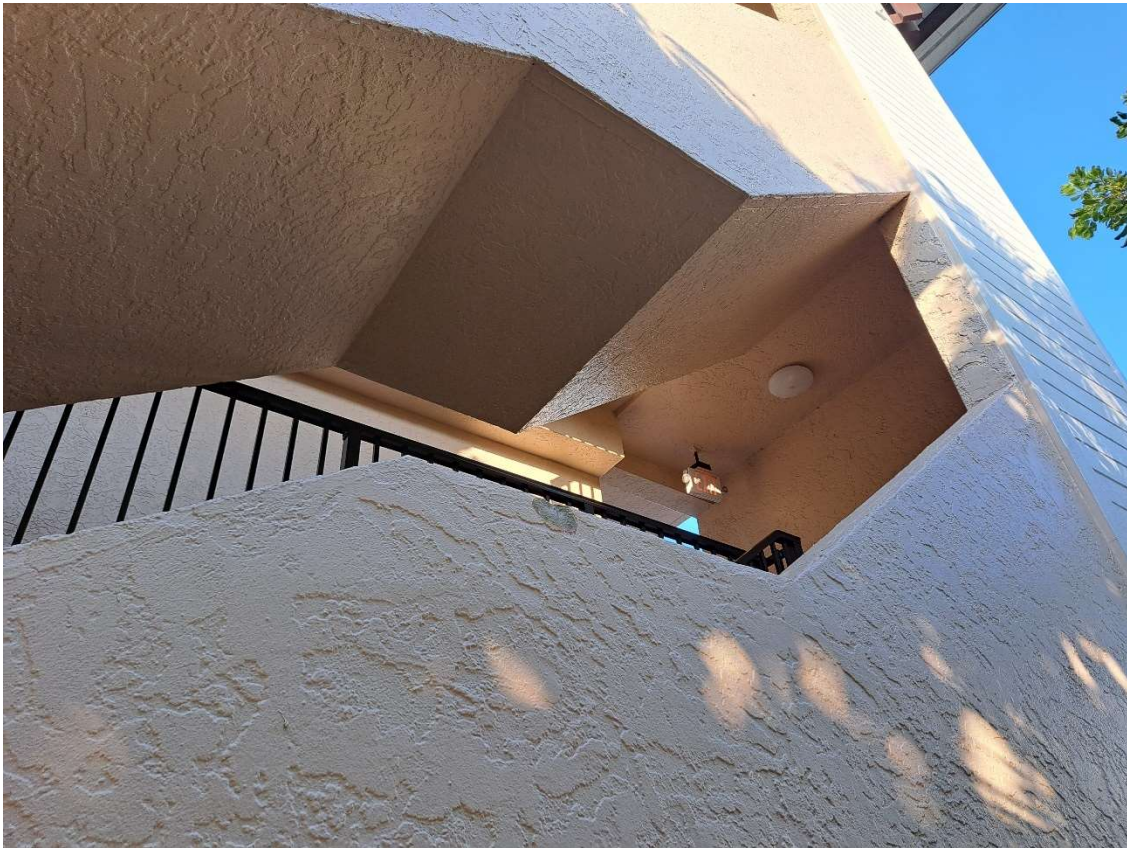
- 2.1.1.1 Multiple locations on the relatively new painted and stuccoed exterior walls are debonded, missing stucco, or damaged (Photos 01, 02, 03, 04, 05, 06, 07, 08, 09, 10). Compromised stucco and or paint allows moisture to hasten the degradation of the underlying concrete. See *Carbonation & the Concrete Spalling / Degradation Process* (pg. 2)

*Photo 01 Ref: 2.1.1.1 – Stucco & Siding Damage*

- 3.1.1.1 As the exterior finishing is still under an active project, the damage should be located and fixed before the project is closed out.
- 3.1.1.2 The runoff from the downspouts should be routed approximately 4 to 5 feet away from the side of the building if possible.
- 3.1.1.3 Debonded stucco should be repaired around the inside of the louvers and any cracks should be routed, filled, re-stuccoed and re-painted.
- 3.1.2 All Non-Substantial Structural Issues should be repaired as soon as possible.

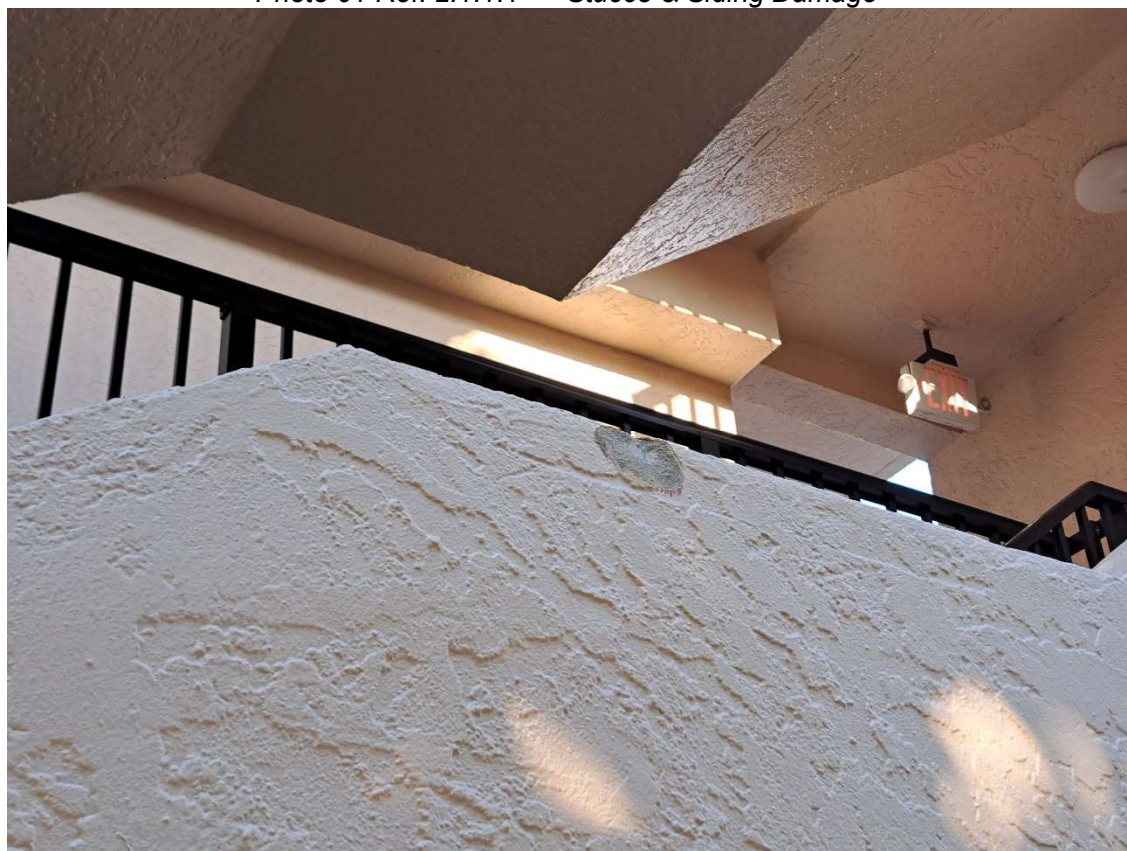
*Photo 02 Ref: 2.1.1.1 – Stucco & Siding Damage*

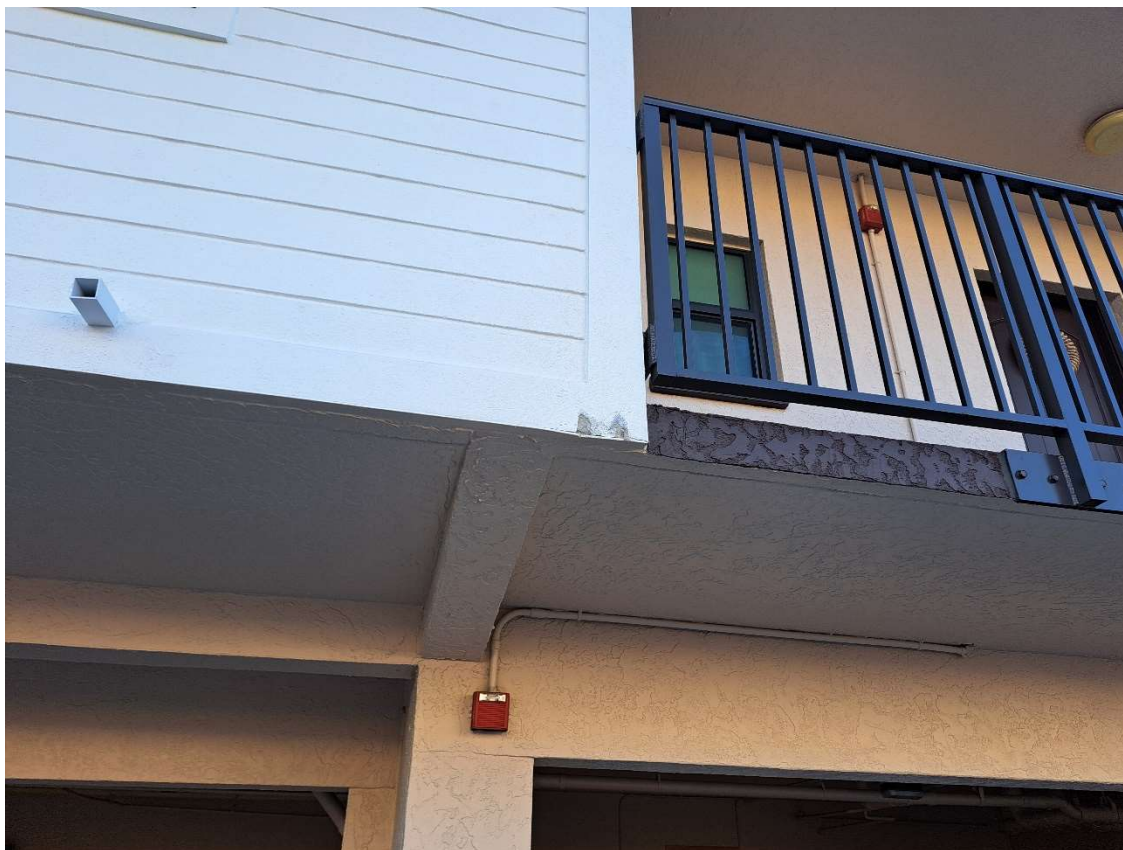
*Photo 03 Ref: 2.1.1.1 – Stucco & Siding Damage*

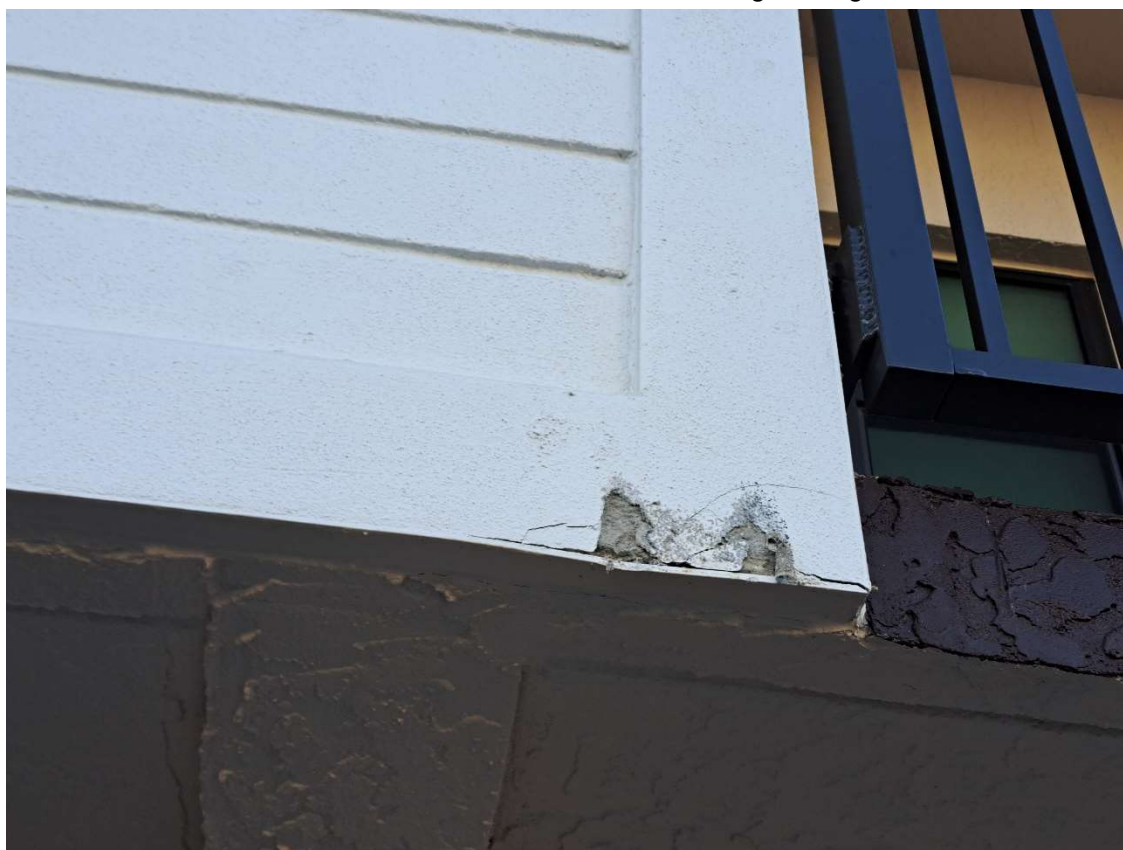
*Photo 04 Ref: 2.1.1.1 – Stucco & Siding Damage*

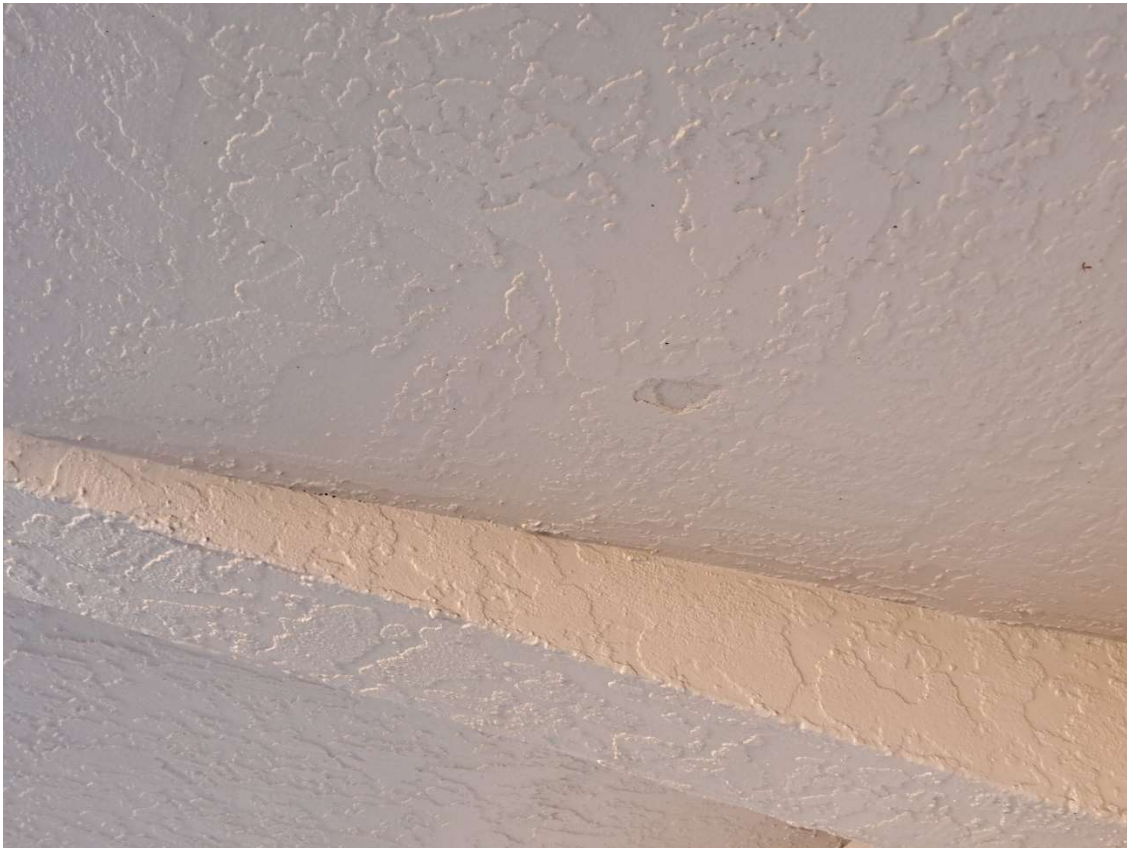
*Photo 05 Ref: 2.1.1.1 – Stucco & Siding Damage*

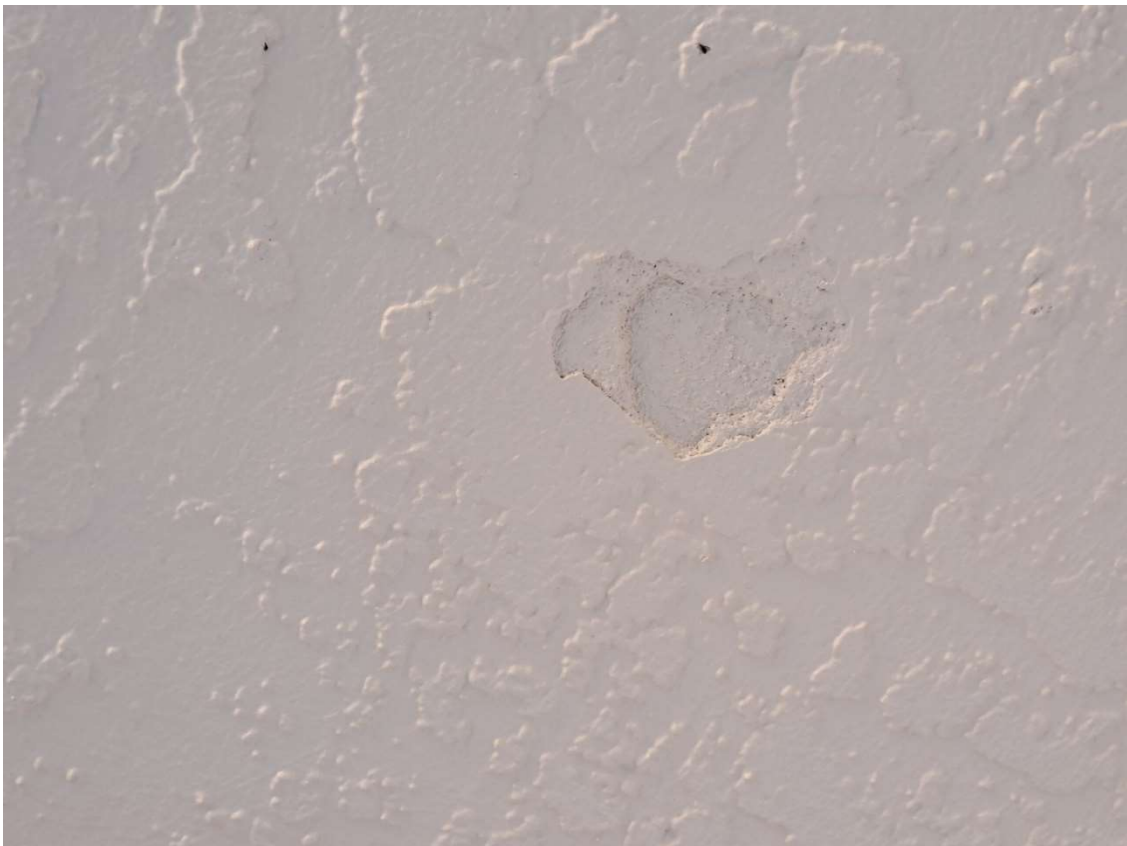
*Photo 06 Ref: 2.1.1.1 – Stucco & Siding Damage*

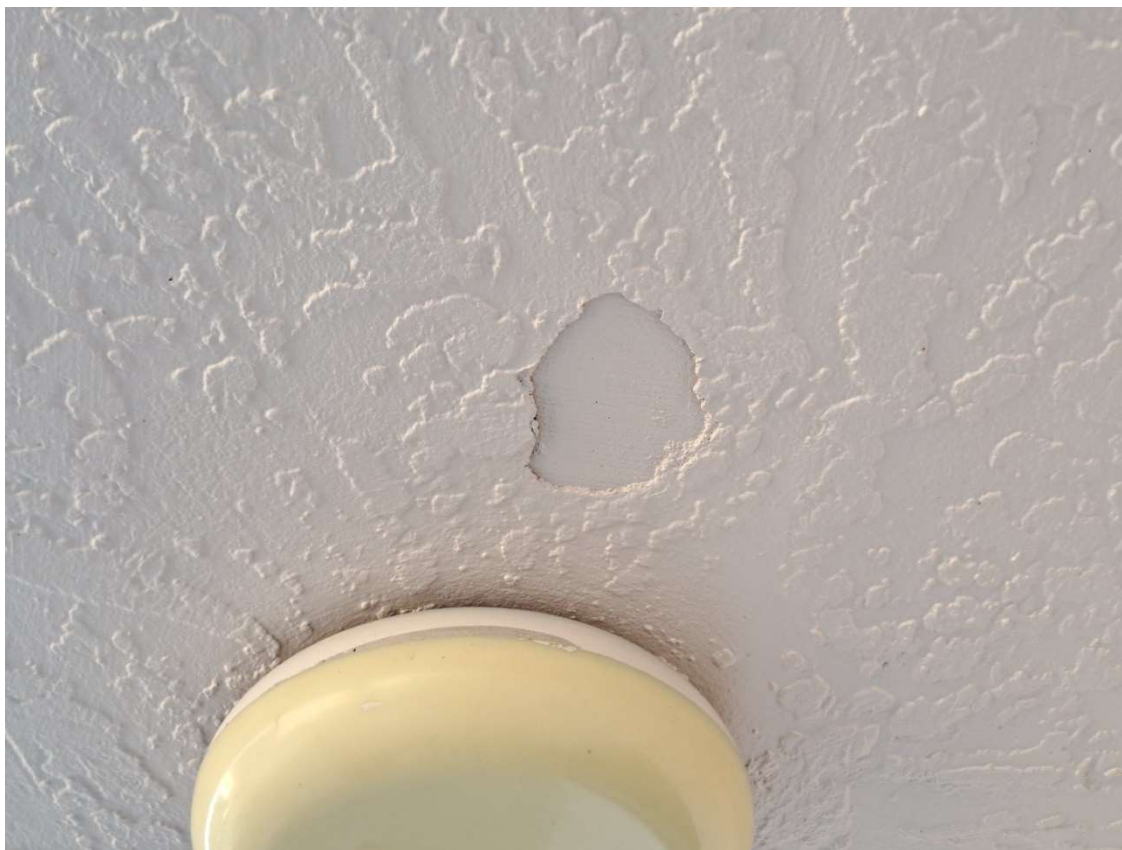
*Photo 07 Ref: 2.1.1.1 – Stucco & Siding Damage*

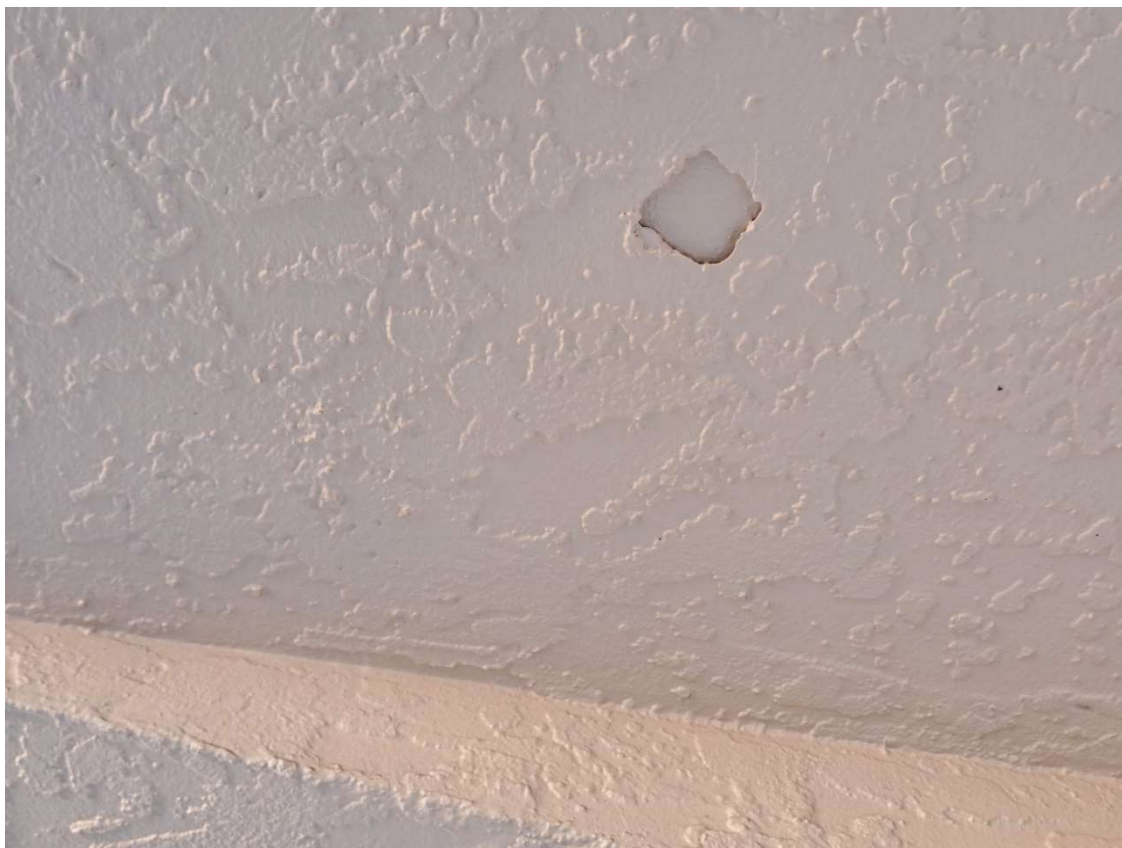
*Photo 08 Ref: 2.1.1.1 – Stucco & Siding Damage*

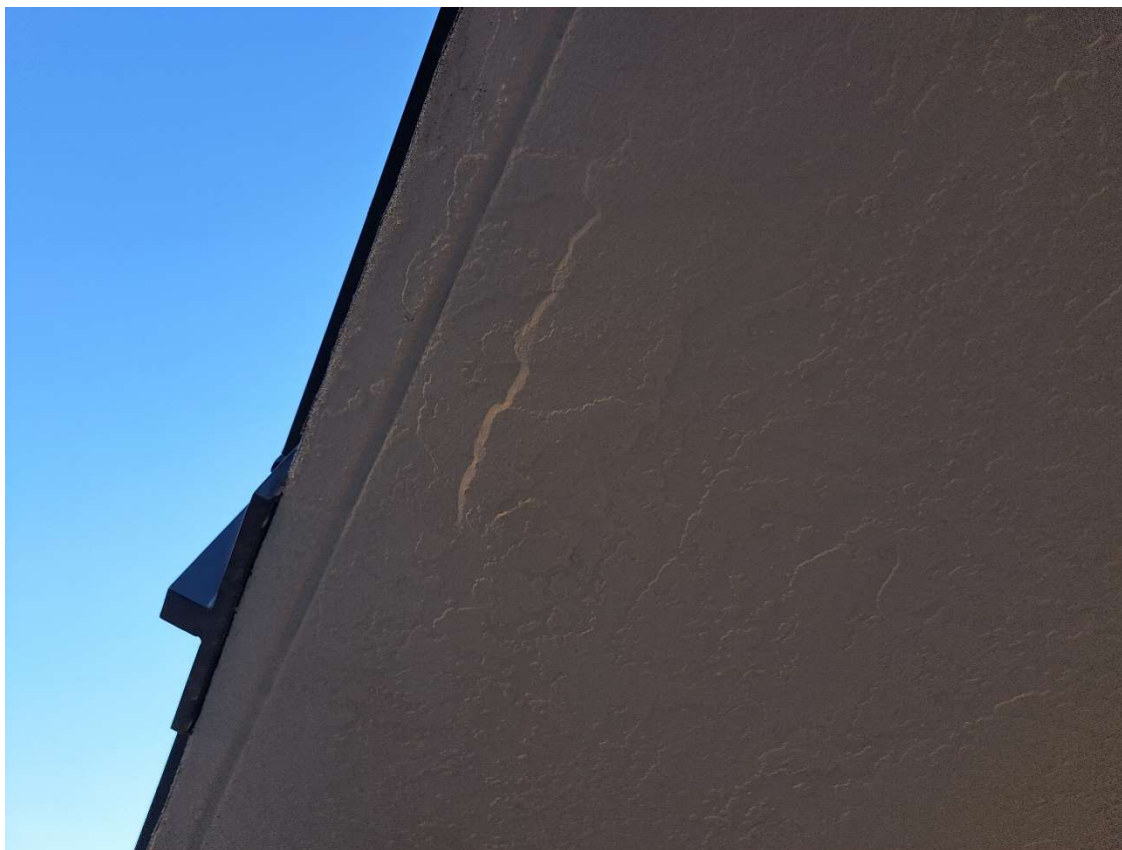
*Photo 09 Ref: 2.1.1.1 – Stucco & Siding Damage*

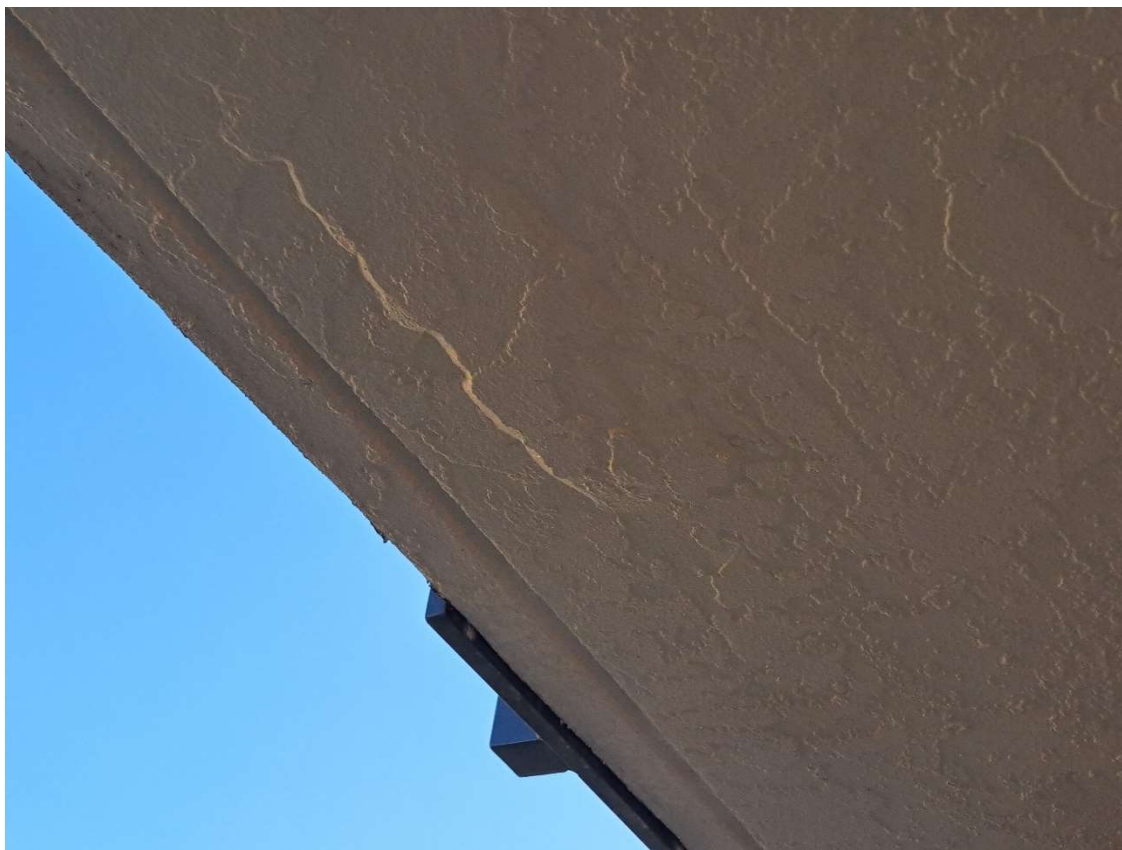
*Photo 10 Ref: 2.1.1.1 – Stucco & Siding Damage*

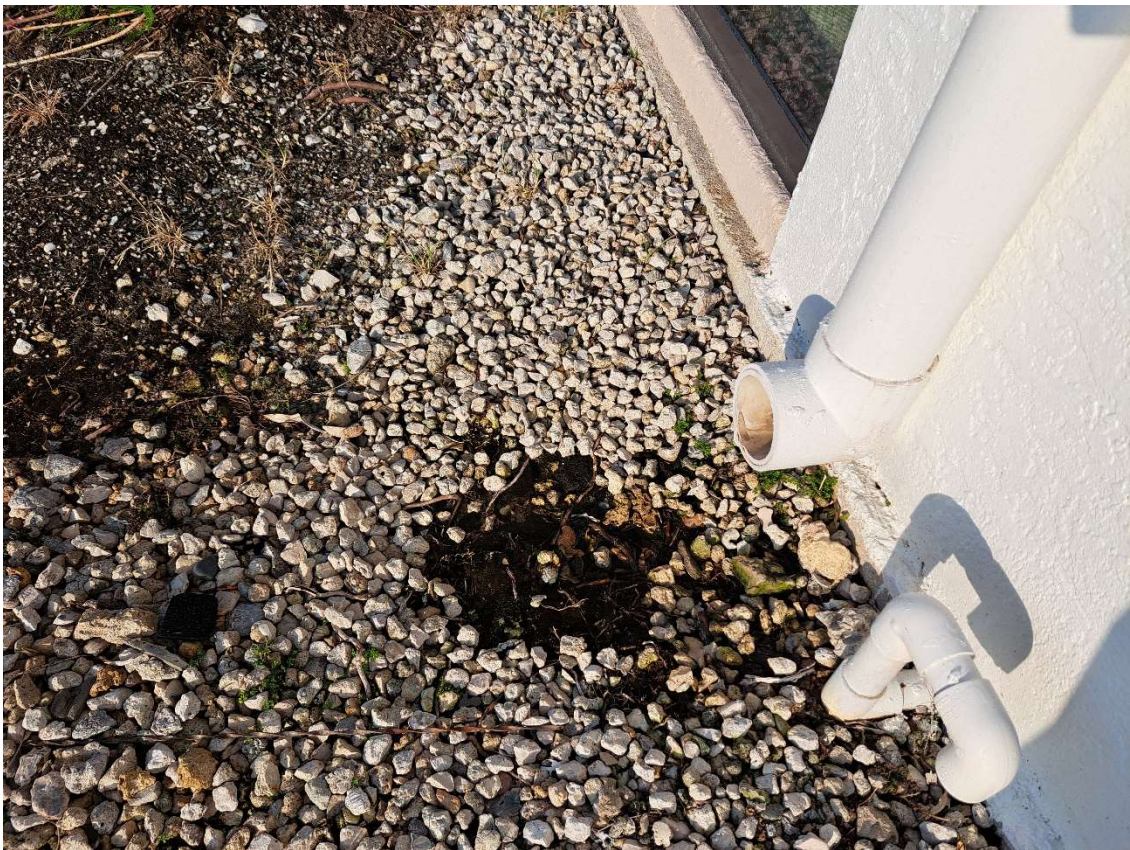
- 2.1.2.1 Downspouts empty too close to the foundation (Photo 11 Typical). Chronic water penetration into the foundation system can accelerate the degradation of the concrete there. This is especially undesirable if the downspout is chronically soaking an underground column or wall footer. See *Carbonation & the Concrete Spalling / Degradation Process* (pg. 2).

Photo 11 Ref: 2.1.2.1 – Downspouts Emptying Next to Foundations

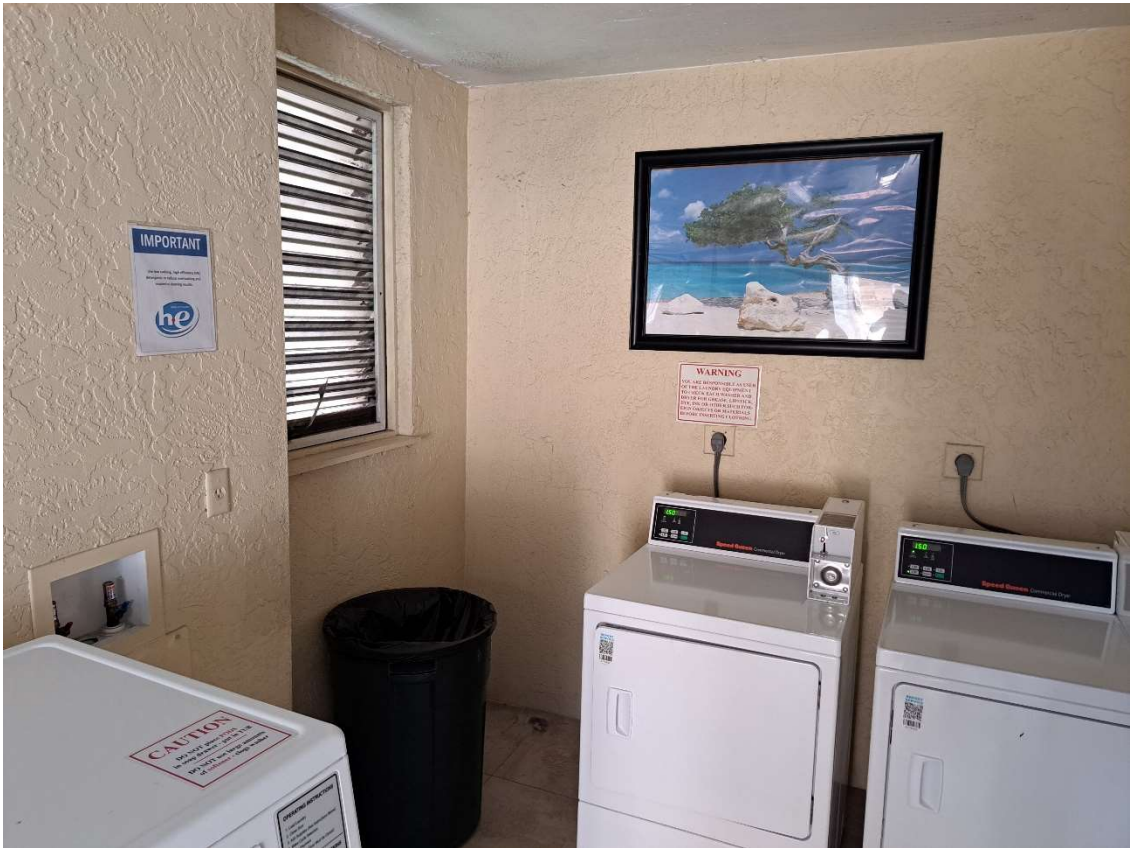
- 2.1.3.1 Some of the walls just inside and below the wall louvers in these rooms have debonded stucco and or cracks between the wall blocks (Photo 12, 13, 14 Typical). Chronic moisture penetration into the walls can accelerate the degradation of the concrete. Debonded stucco can be a sign that water has found it's way between the stucco and concrete. Even if the block wall might not be a supporting wall, moisture could find it's way down to the poured floor slab via these penetrations. See *Carbonation & the Concrete Spalling / Degradation Process* (pg. 2).

Photo 12 Ref: 2.1.3.1 – Debonded Stucco and Cracks in Louvered Corner Rooms

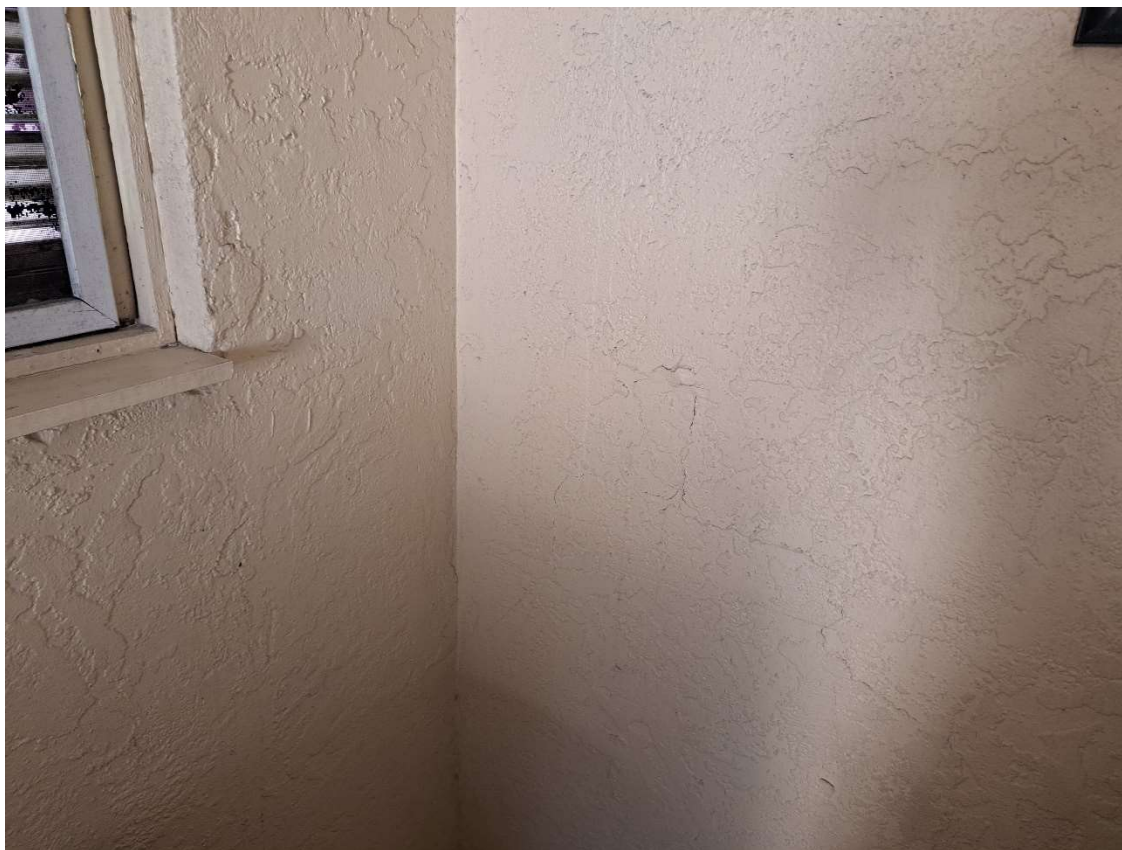
*Photo 13 Ref: 2.1.3.1 – Debonded Stucco and Cracks in Louvered Corner Rooms*

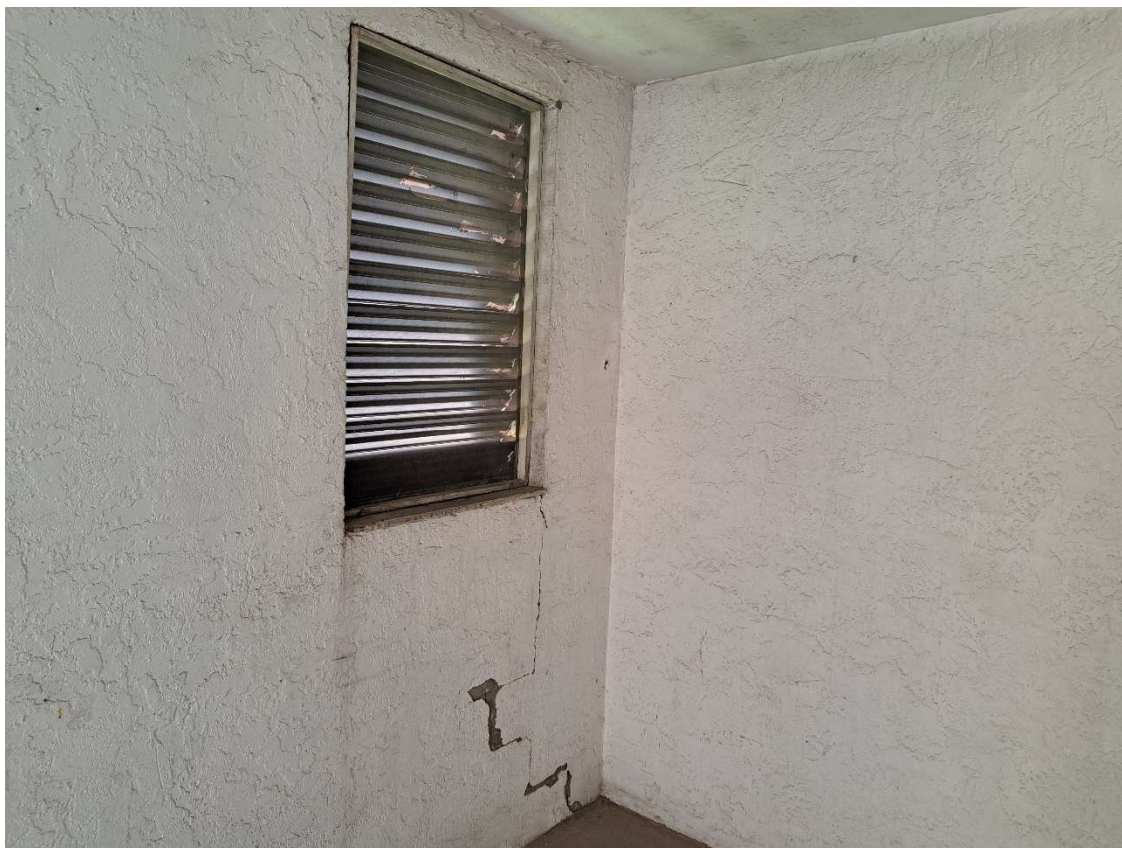
*Photo 14 Ref: 2.1.3.1 – Debonded Stucco and Cracks in Louvered Corner Rooms*
