Milestone Inspection Report Phase 1

Beaumer Condominium Association, Inc.

**805 Riverpoint Drive, Building B 803
Naples, FL 34102**

Prepared on:
5/24/2024

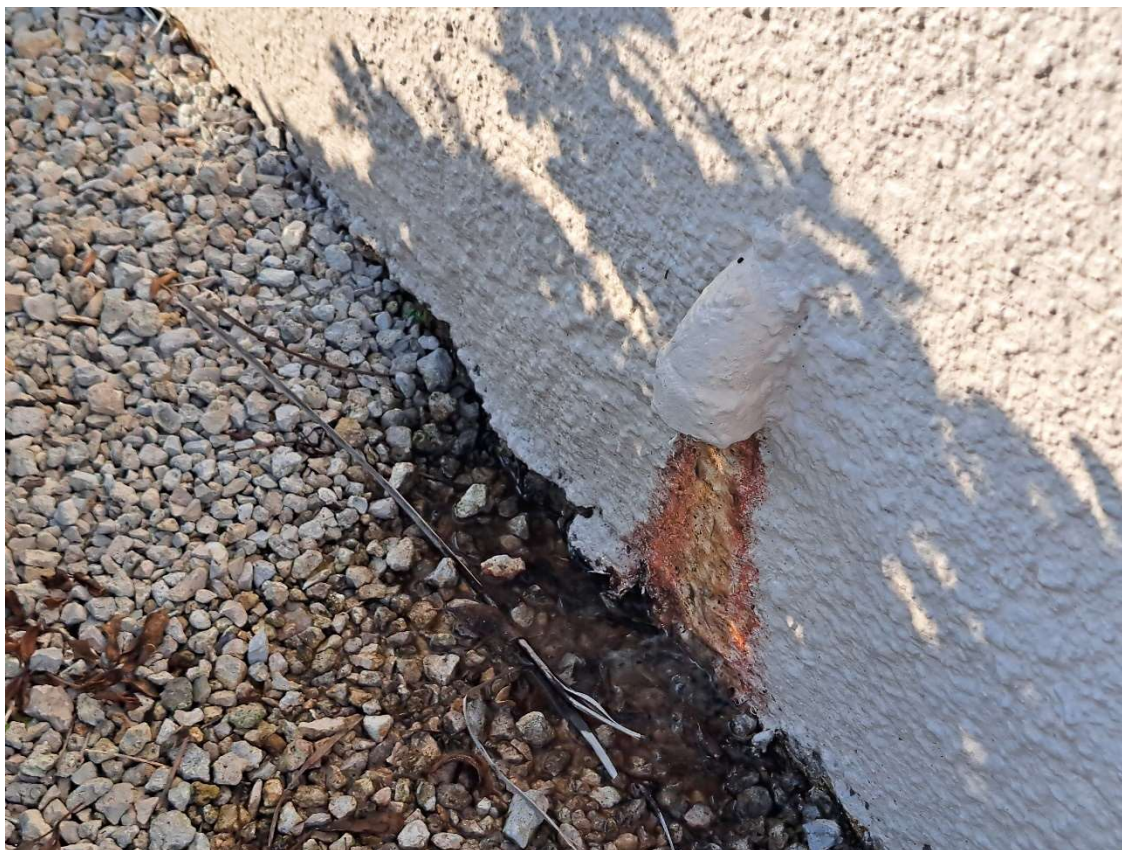
- 2.1.1.1 Downspouts empty too close to the foundation (Photos 01, 02 Typical). Chronic water penetration into the foundation system can accelerate the degradation of the concrete there. This is especially undesirable if the downspout is chronically soaking an underground column or wall footer. See *Carbonation & the Concrete Spalling / Degradation Process* (pg. 2).

Photo 01 Ref: 2.1.1.1 – Downspouts Emptying Next to Foundations

- 3.1.1.1 The runoff from the downspouts should be routed approximately 4 to 5 feet away from the side of the building if possible.
- 3.1.1.2 The exposed concrete in the elevator equipment room should be coated with paint.
- 3.1.1.3 The uppermost flashing around the fire hydrant pipe on the roof should be re-done.
- 3.1.2 All Non-Substantial Structural Issues should be repaired as soon as possible.

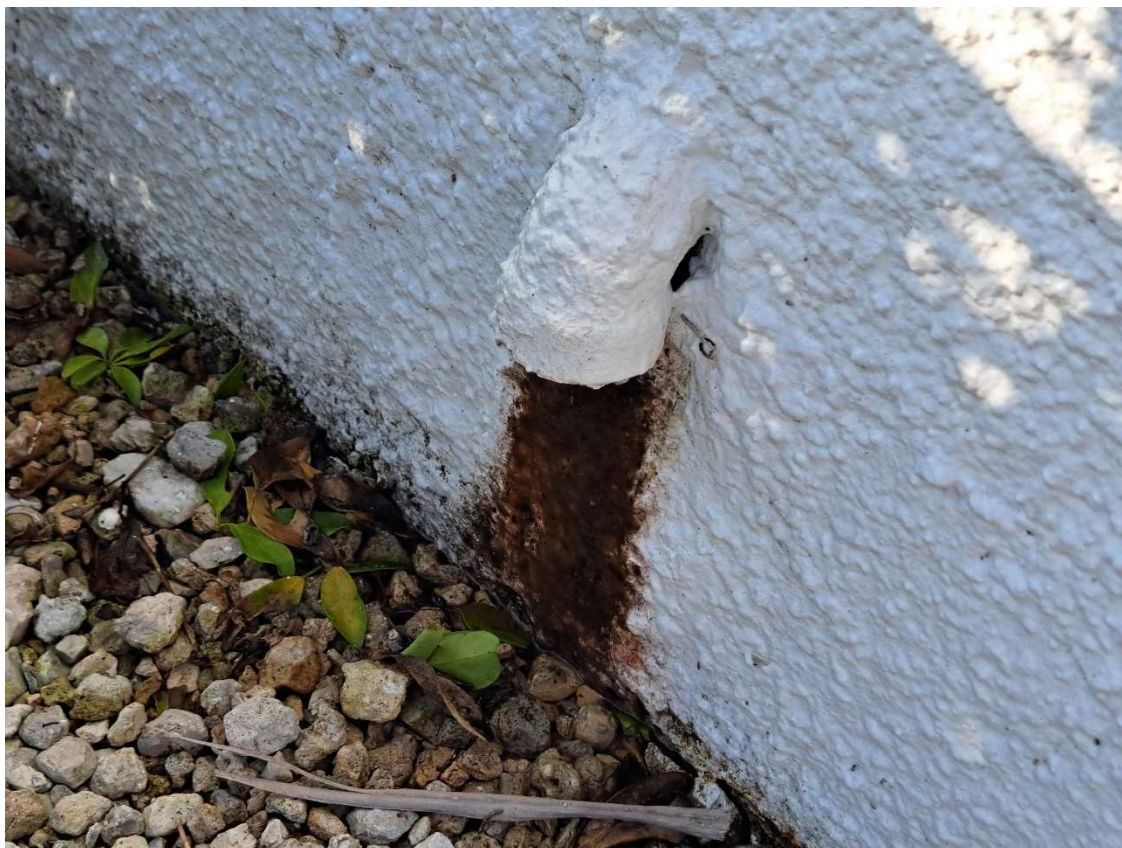
Photo 02 Ref: 2.1.1.1 – Downspouts Emptying Next to Foundations

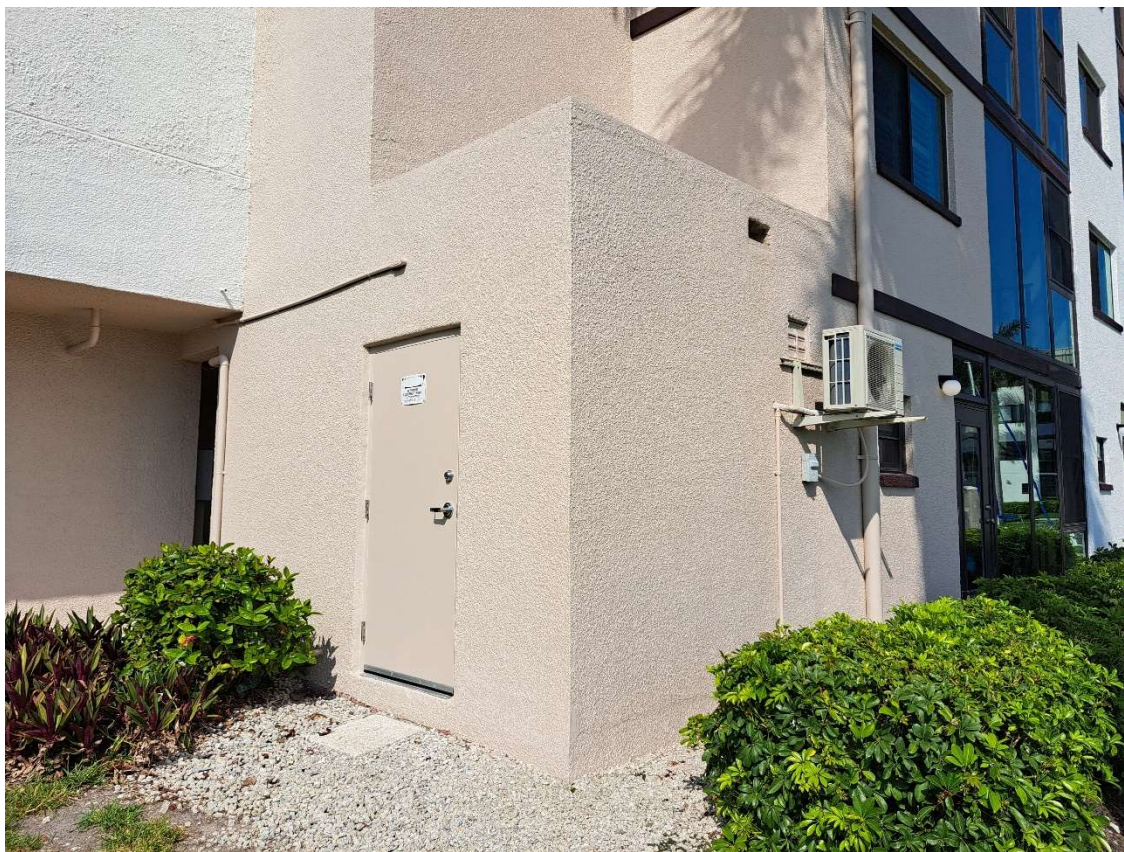
- 2.1.2.1 A section of a column inside the equipment room has no stucco or paint on it and has had the outer layer of concrete removed (Photos 03, 04, 05). Paint helps seal concrete against moisture in the air which accelerates the degradation of the concrete. See *Carbonation & the Concrete Spalling / Degradation Process* (pg. 2).

Photo 03 Ref: 2.1.2.1 – Unpainted Section of a Column in Elevator Room

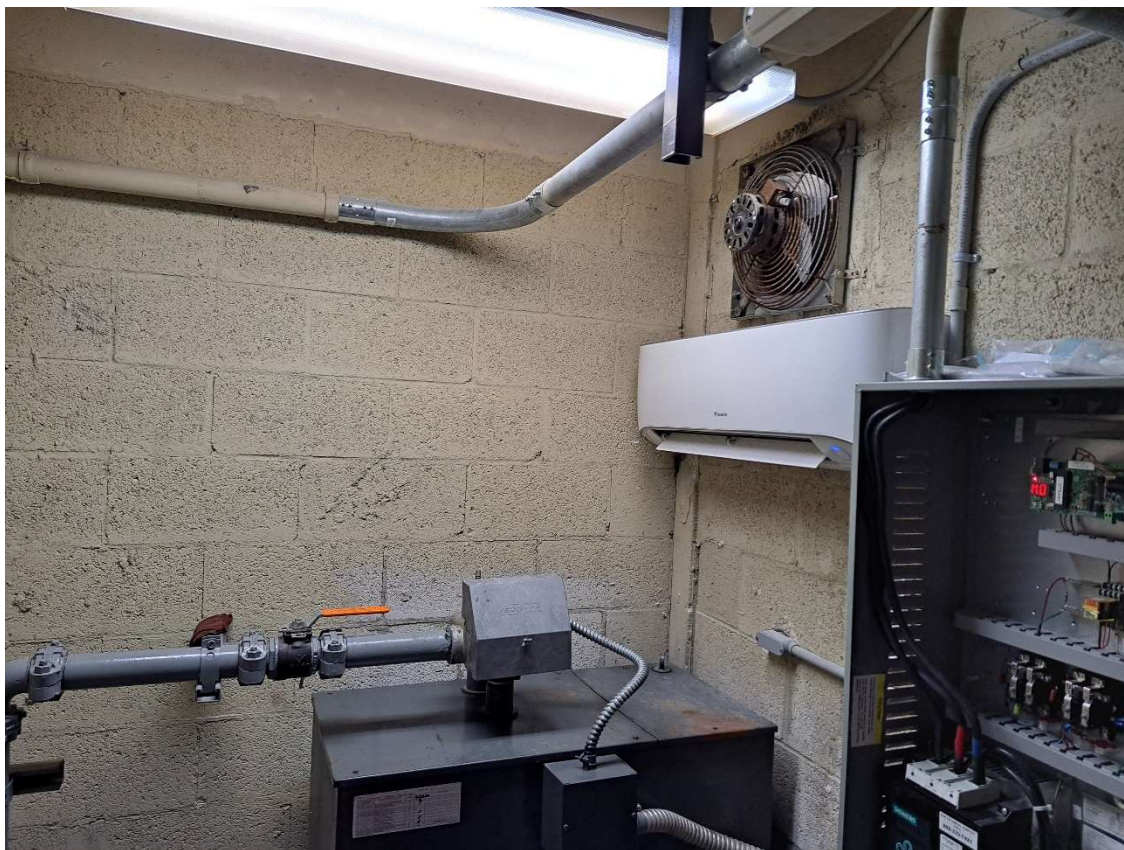
Photo 04 Ref: 2.1.2.1 – Unpainted Section of a Column in Elevator Room

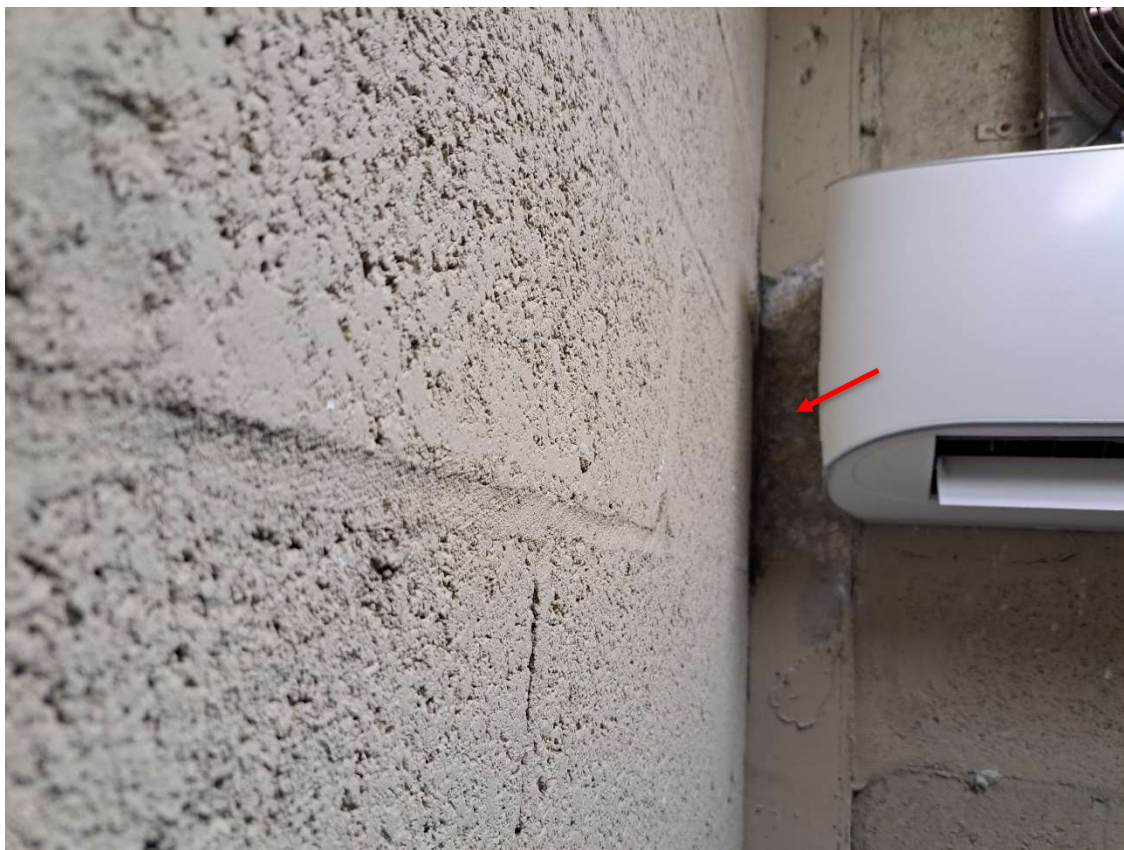
Photo 05 Ref: 2.1.2.1 – Unpainted Section of a Column in Elevator Room

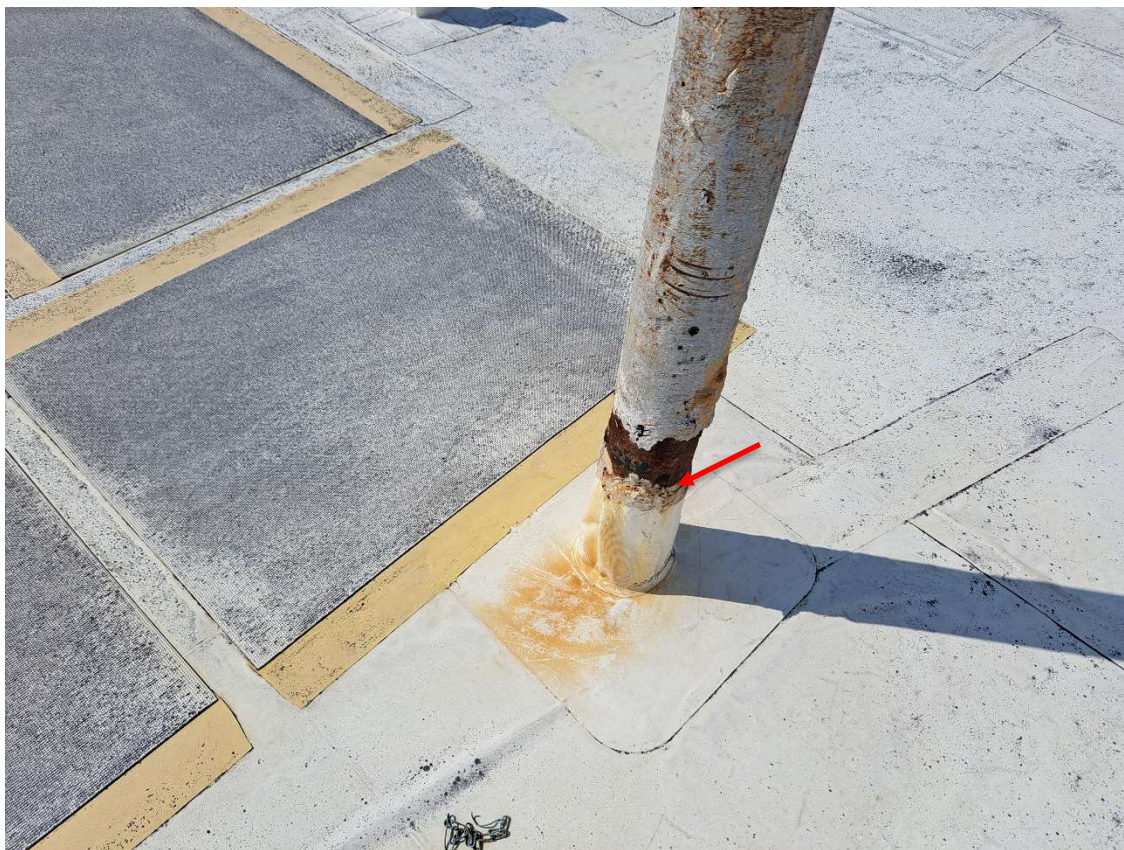
- 2.1.3.1 The upper flashing around the fire hydrant pipe on the roof, is damaged (Photo 06). This will soon allow rain to bypass the roof and dribble down the outside of the pipe and into the building structure. Moisture accelerates the degradation of the concrete. See *Carbonation & the Concrete Spalling / Degradation Process* (pg. 2).

Photo 06 Ref: 2.1.3.1 – Damaged Upper Flashing of the Fire Hydrant Pipe on the Roof
