# Milestone Inspection Report Phase 1

## Beaumer Condominium Association, Inc.

**805 Riverpoint Drive, Building D 807  
Naples, FL 34102**

Prepared on:  
**5/24/2024**

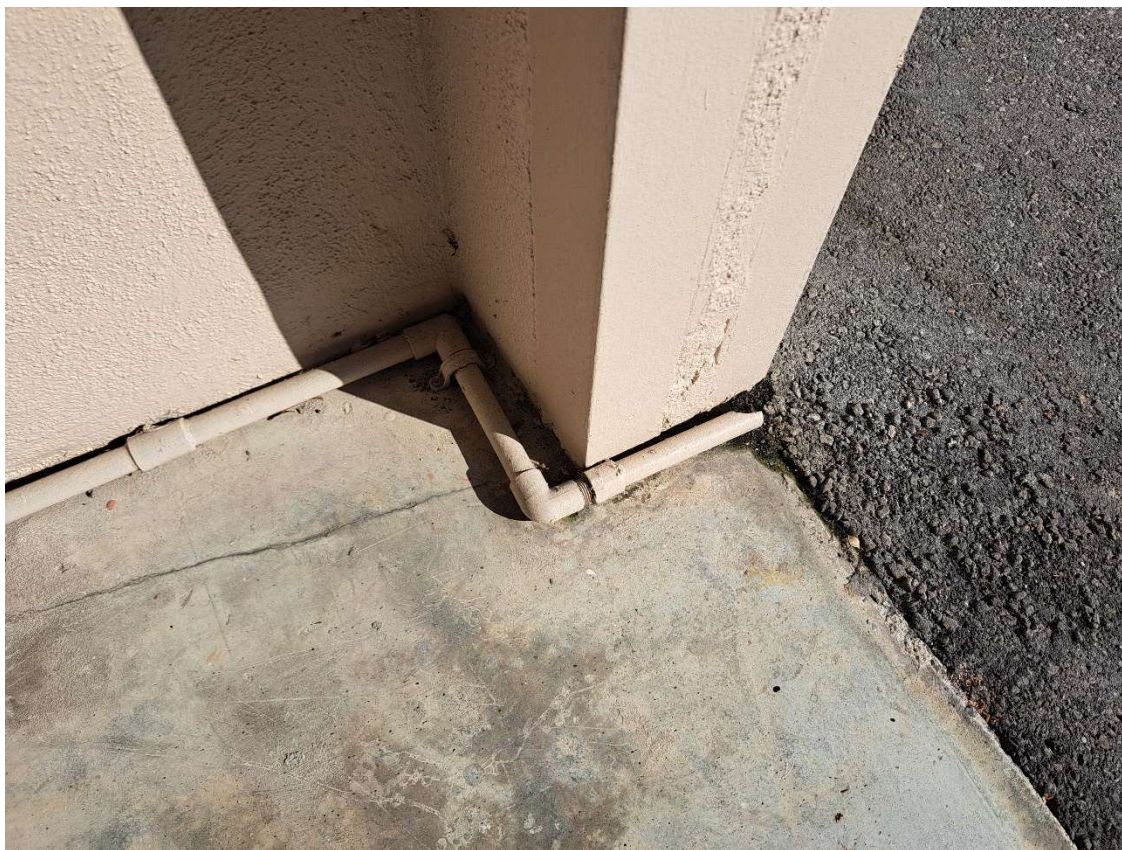
- 2.1.1.1 One air conditioner was draining directly onto the garage floor (Photo 01). Downspouts and air conditioner drains empty too close to the foundation. Chronic water penetration into the foundation system can accelerate the degradation of the concrete there. This is especially undesirable if the seepage is chronically soaking an underground column or wall footer. See *Carbonation & the Concrete Spalling / Degradation Process* (pg. 2).

*Photo 01 Ref: 2.1.1.1 – Air Conditioner Draining Next To Foundation*

3.1.1.1 The runoff from the air conditioner units should be routed approximately 4 to 5 feet away from the side of the building (especially where footers are located) if possible.

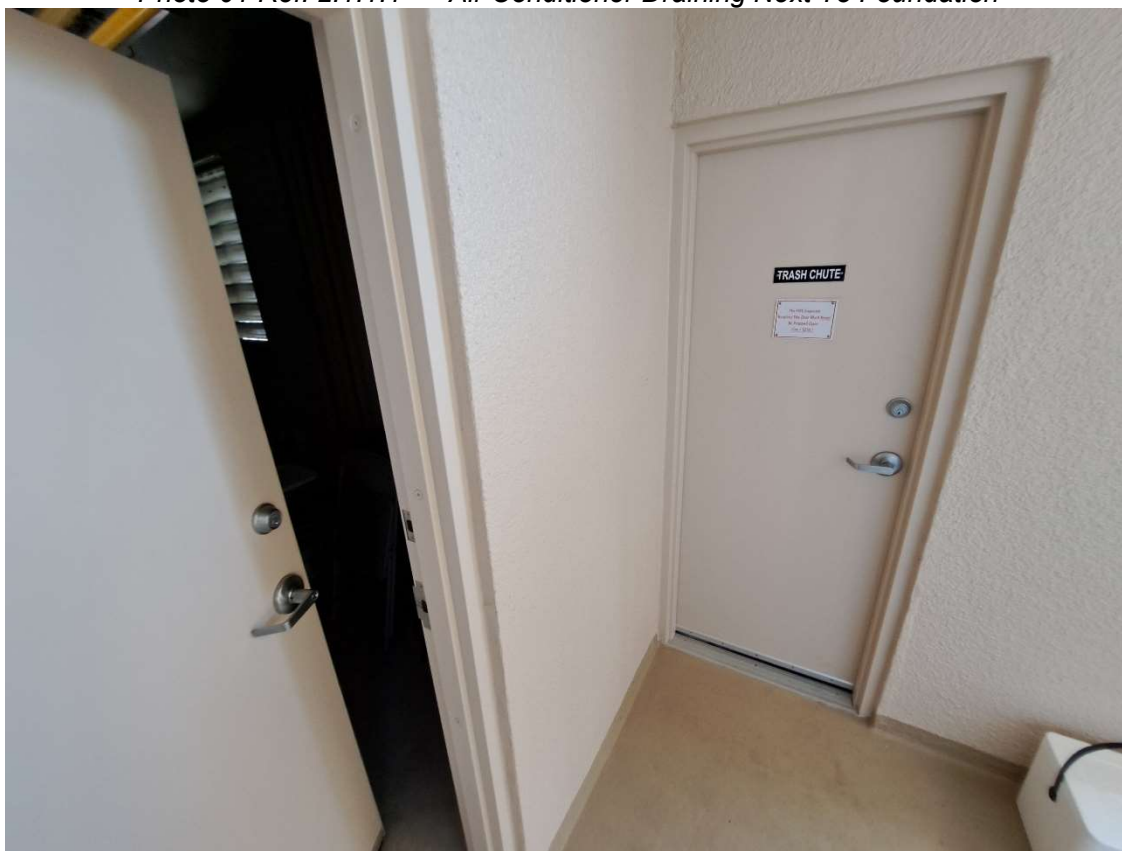
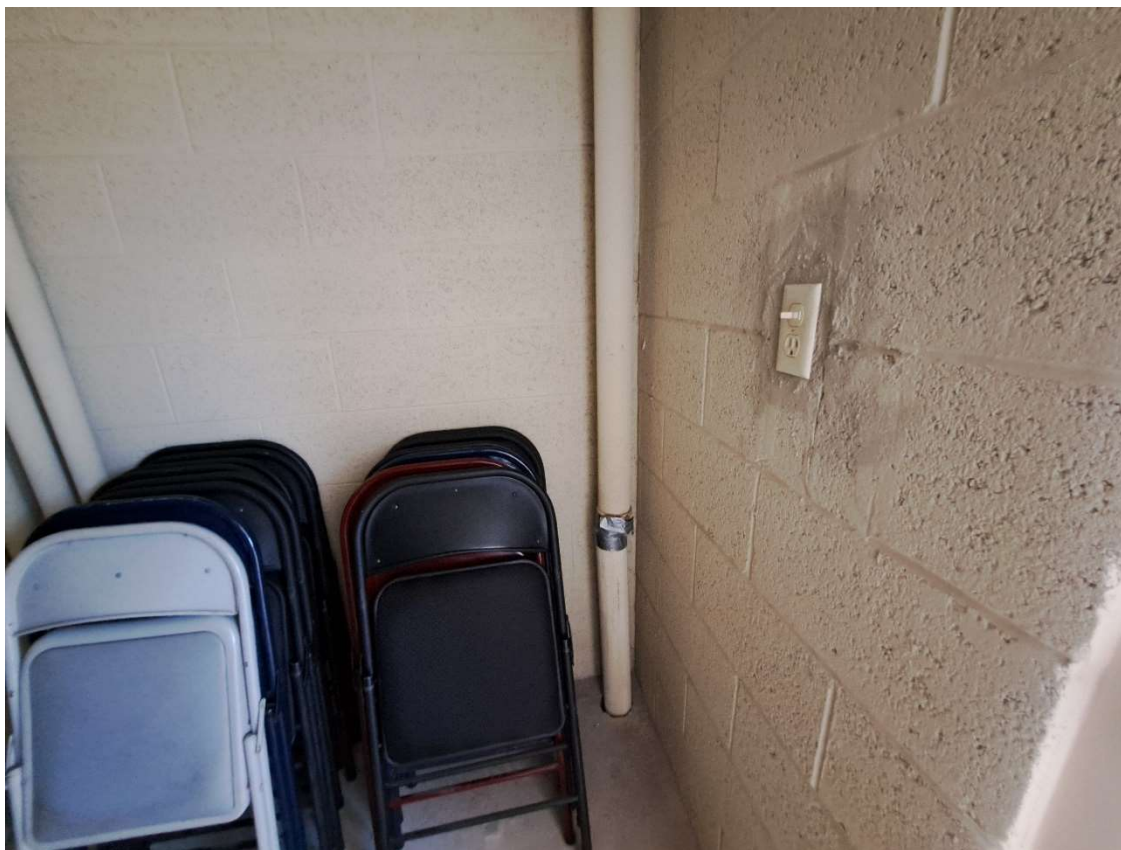
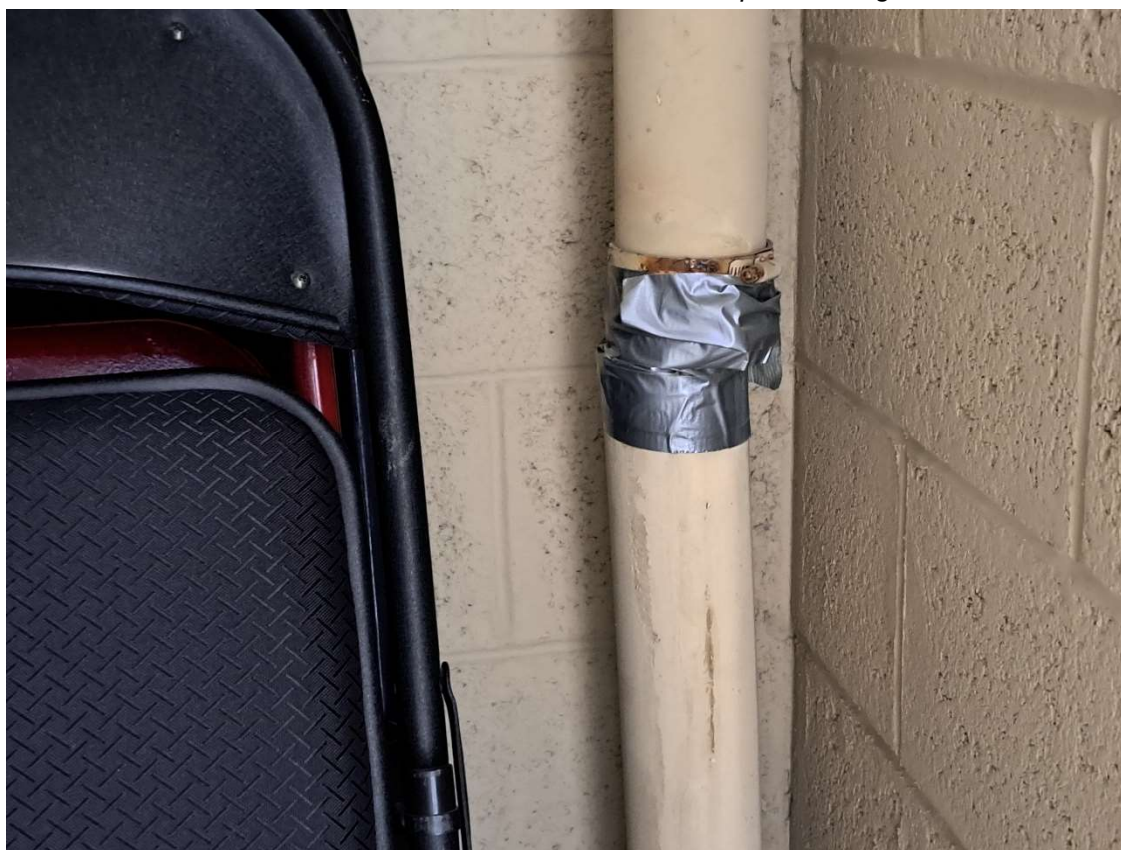
- 2.1.2.1 A vertical vent, or drain pipe; in a storage room has a joint which is decoupled and slightly offset (Photo 02, 03, 04). This can let rain from the roof or water (if it is a drain) dribble out of the coupling, down along the outside of the pipe and onto the floor. This could create a chronically wet location where the pipe meets the floor. Moisture accelerates the degradation of the concrete. See *Carbonation & the Concrete Spalling / Degradation Process* (pg. 2).

*Photo 02 Ref: 2.1.2.1 – Offset Drain or Vent Pipe in Storage Room*

*Photo 03 Ref: 2.1.2.1 – Offset Drain or Vent Pipe in Storage Room*

*Photo 04 Ref: 2.1.2.1 – Offset Drain or Vent Pipe in Storage Room*

3.1.1.2 The decoupled drain or vent pipe in the storage room should be repaired.
